Manhole Inspection Summary

Manhole # S15GG1008MH

Location Address: **2528 QUANTICO AVE**

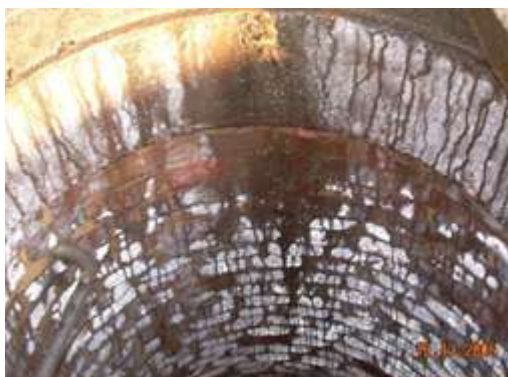
Defect

Frame Offset: **0** (in.) Condition: ☐ Sound ☐ Cracked ☒ **Leaks**

Infiltration: ☐ None ☒ **Joint** ☐ Cracks ☒ **Mortar** ☐ Roots ☐ Wall

Frame leaks. Corbel infiltration..

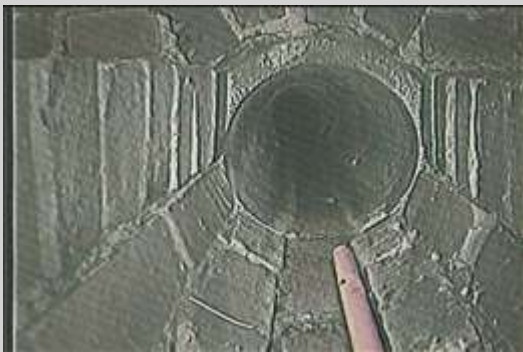
8 in. Circular Gravity Sewer Pipe Out @ 12 O'Clock

Infiltration: **Evidence** Pipe Seal Cond: **Cracked**

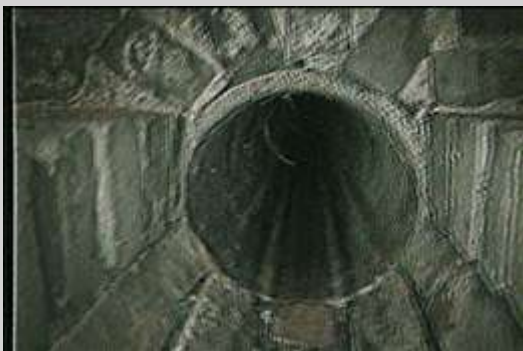
8 in. Circular Gravity Sewer Pipe In @ 6 O'Clock

Infiltration: **Evidence** Pipe Seal Cond: **Unknown**
